Summary #3 of Damage to Marginal Way Nor'easter March 3-5, 2018 Edited 3.29.18

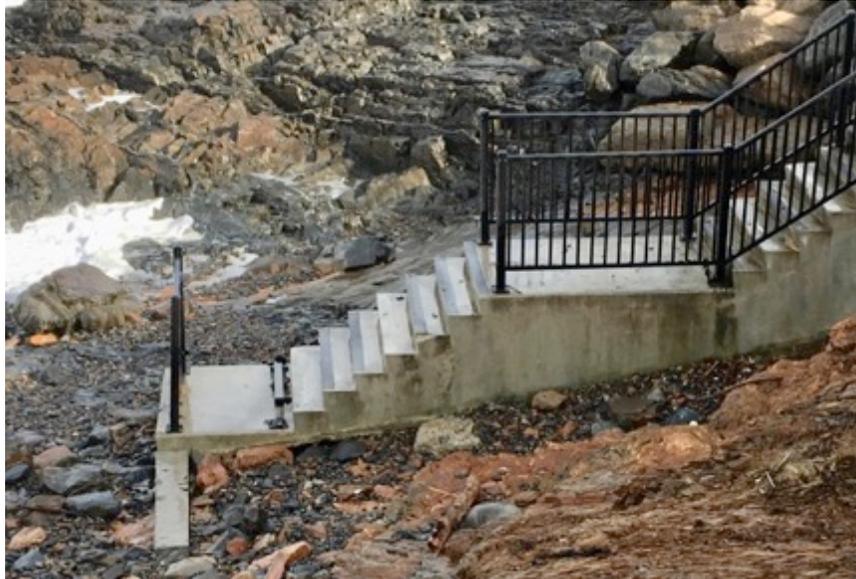
1. PRIORITY - Lower section of railings to Little Beach. Find out from fence company if lower sections can be constructed so they can be removed each winter.

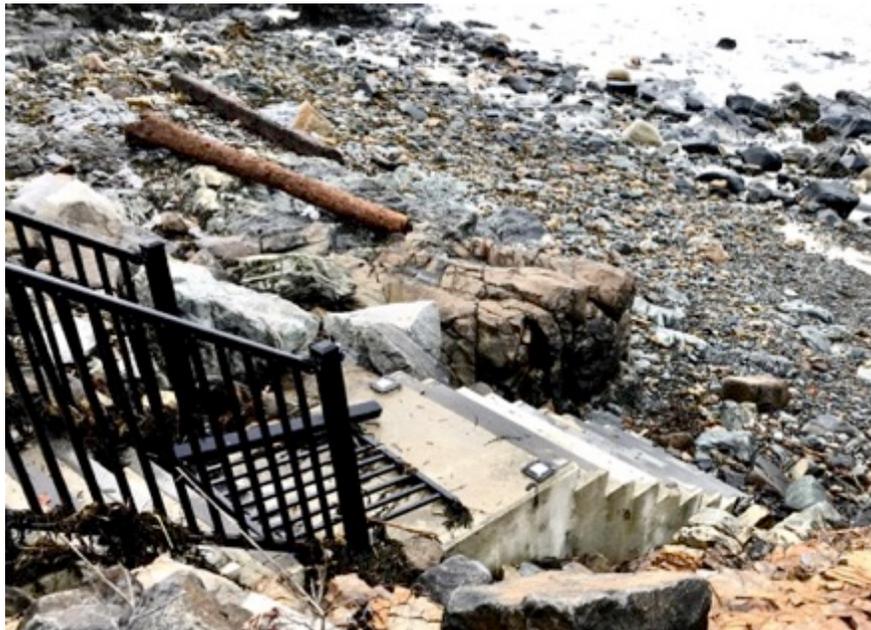
2. PRIORITY - Lower sections of railings to staircase broken away at Mother's Beach. These railings are particularly vulnerable and have been broken apart almost yearly since installation. Devise different fastening system and remove them for the winter? People still go down onto the beach year round, no matter what.

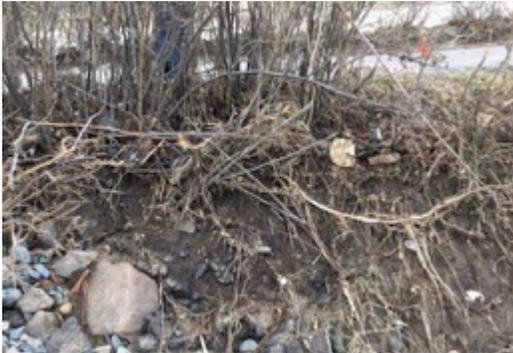
3. South of Bench 8, reinforcement needed behind bushes where soil eroded. Extension of rocks that should be added to protect path at site #4

From S side of Bench platform (which needs more rocks in front of it) going N – **157' to bushes,**
170' if go behind bushes.

Do not remove more vegetation.

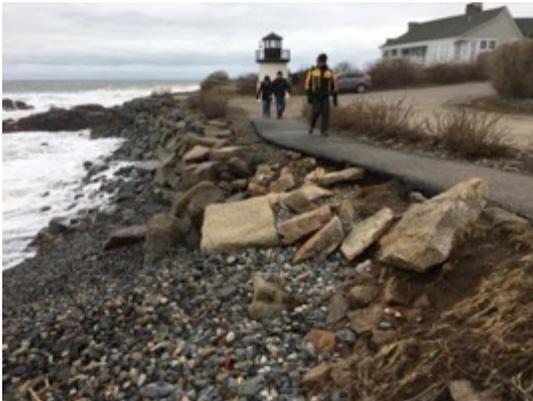
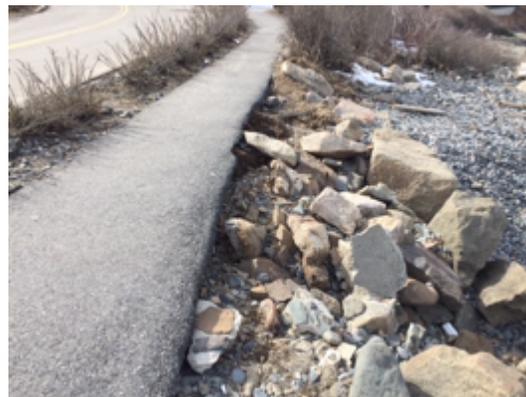
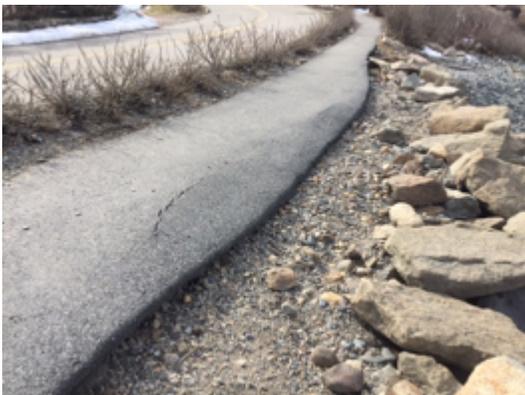
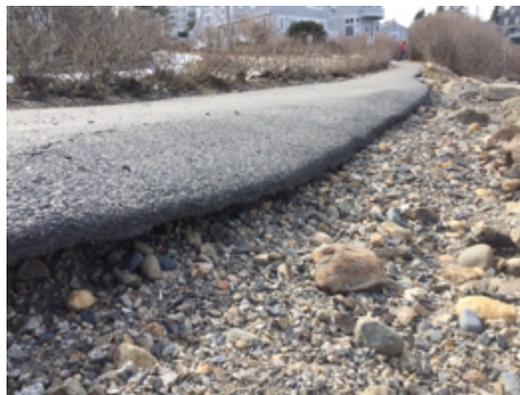
4. HIGH PRIORITY - At base of Israel Head Rd. and Stearns Rd., erosion on ocean side of paving. Large rocks were dislodged, and soil was washed out under paving 6" to 18". Needs stronger longer lasting reinforcement of asphalt than just stone dust and gravel. Some type of revetment may be needed here. We must preserve access to cobble beach.

By 3.23.18, unsupported paving has **collapsed. 16'**

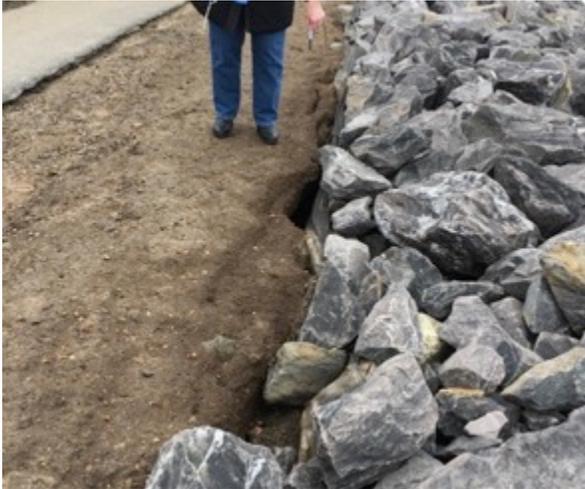
5. Along Lighthouse revetment, free up and raise the landscape cloth that is meant to hold the soil from leaching out into the rocks. The storm shifted many revetment rocks onto the cloth and buried the cloth in places so that it is well below soil level.

Pavement broken in front of Peloquin home

Serious erosion starting in front of Feldman home. Cloth buried, soil drops off.

More soil will be needed in planting area.

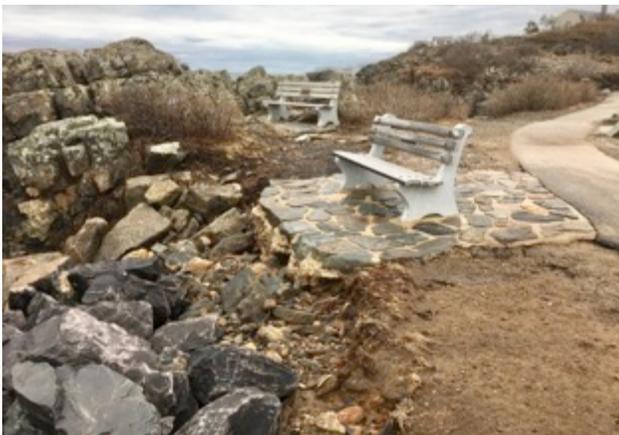
6. Bench 12 – place more stones in front of bench platform extending south from the revetment. Despite the huge natural outcrop next to the bench, this site experienced significant wave action that shifted and moved rocks away from the platform.

Place landscape cloth at N side of bench apron to hold soil line

On S side platform, fill in – reinforce at corner cut in.

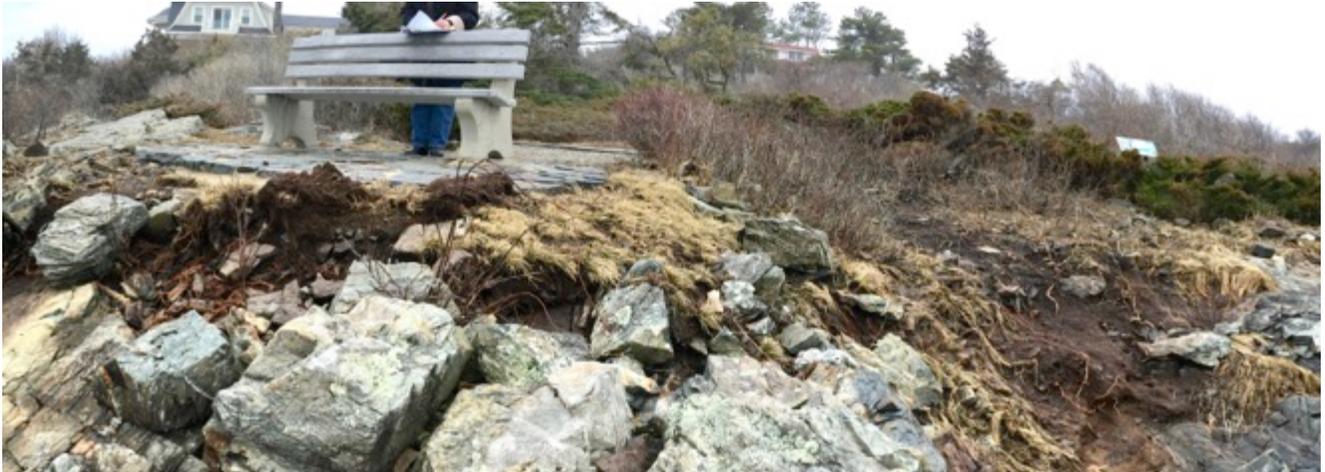
7. Bench 22 - Erosion of soil at base of platform as well as the area to the north of bench (right side of photo). How prevent further erosion?

Rope off and post fragile edge here

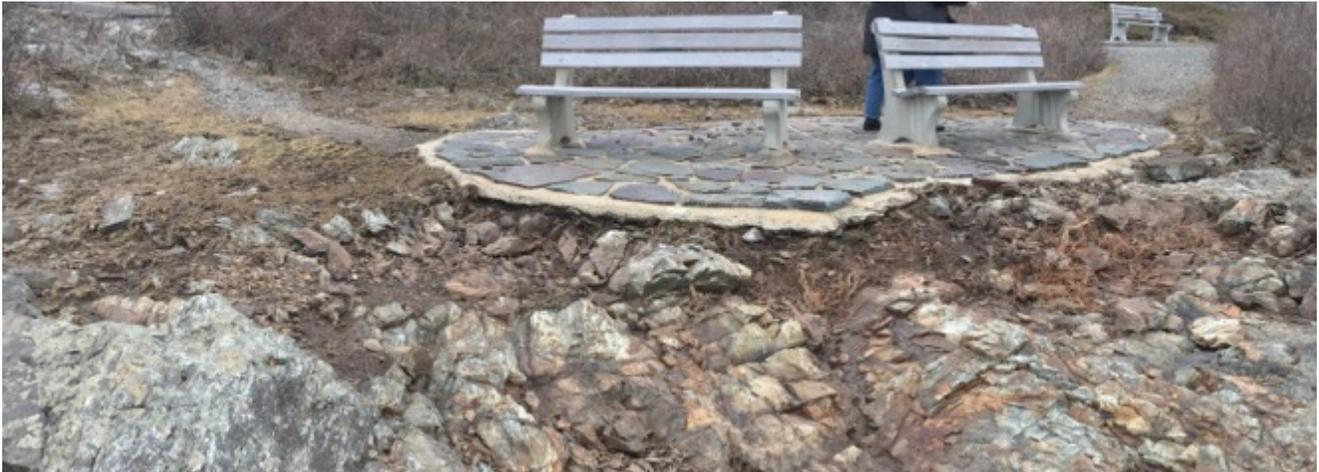
8. Benches 23 & 24 – LOW priority now. The rock surrounding the bench platform has, as our geology consultant Arthur Hussey said, a very weak crumbly quality that will continue to break apart, leaving the platform vulnerable. Gather ideas of how to stabilize the ground around the platform.

ATTENTION Now: In the top left hand corner of photo, the edge of the asphalt where it drops off going in to the benches needs to be reinforced. A gully has formed because of water runoff.

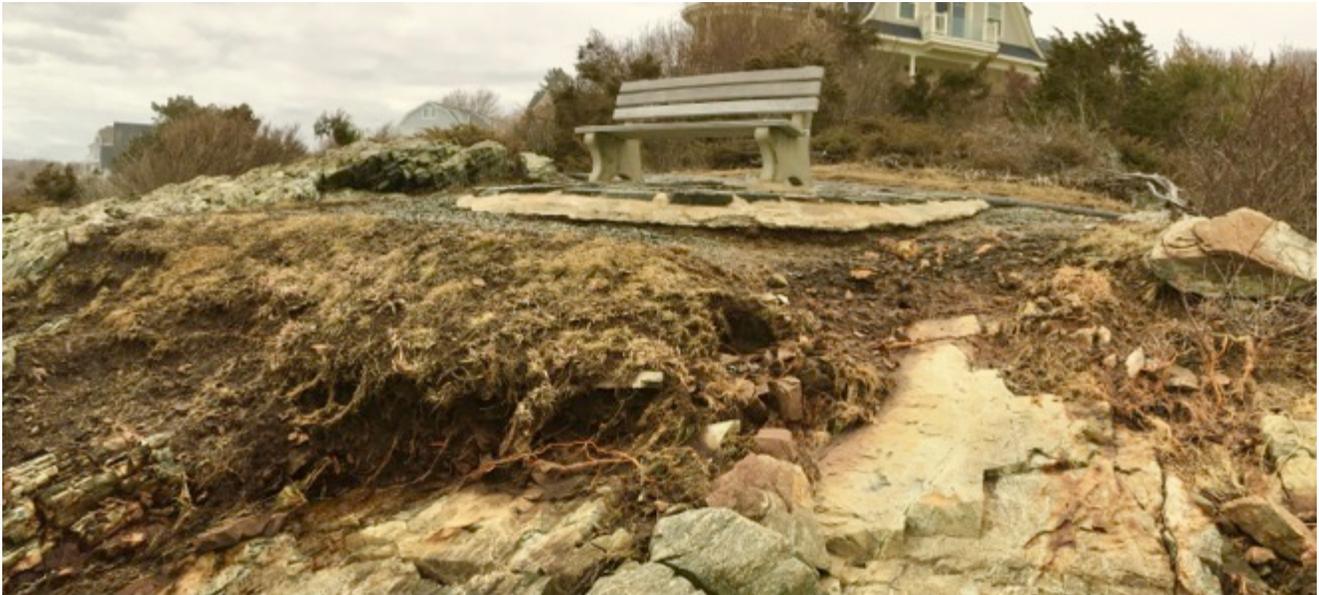
9. Bench 25 – Six feet in front of the bench platform, serious undercutting of soil. Need to stabilize and preserve the earth embankment that we still have. Otherwise, there will eventually be a sharp dropoff from the bench apron

Rope off and post as a fragile edge in front of bench so that we do not lose any more ground.

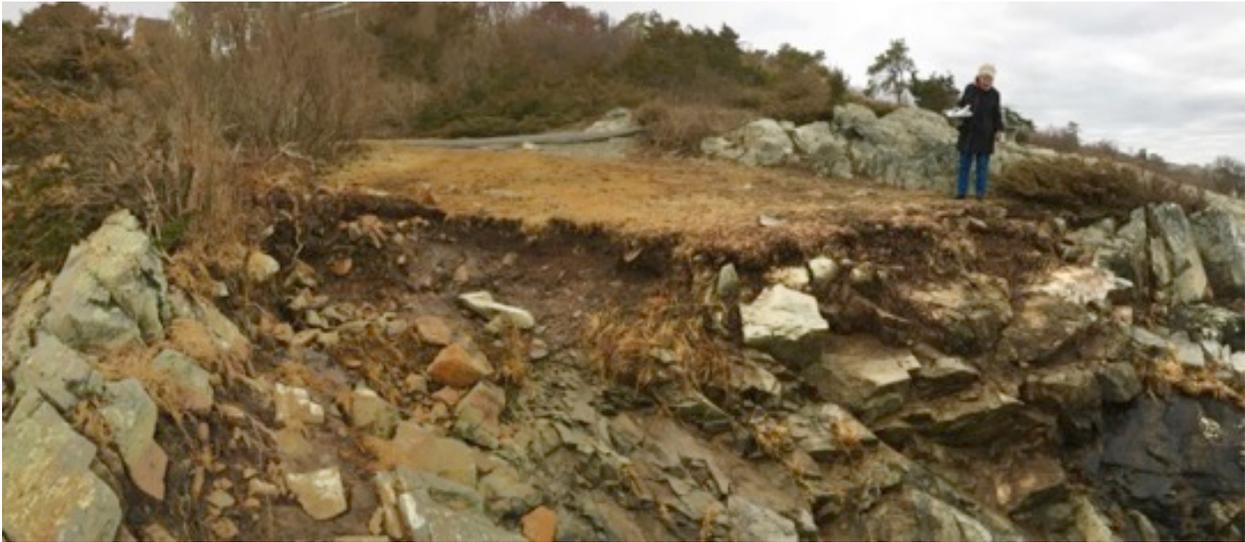
10. **PRIORITY** - 'Winterberry meadow' - Oceanside, south of Bench 25. This small area is one of only two spots on the path that is continually moist. Because of this moisture, we find the only Marsh fern on the path, as well as an impressive old stand of native Winterberry that we want to preserve, as well as what remains of the grass area. Access difficult to bring in material. Solutions suggested: large rocks *carefully* placed and pinned (not just *dumping* rocks) to hold the ground, *or* a wall. Any wall will need sufficient weep holes to deal with existing wet conditions as well as storm runoff.

Rope off edge as fragile to prevent further breakdown of loose rocks and grass edges

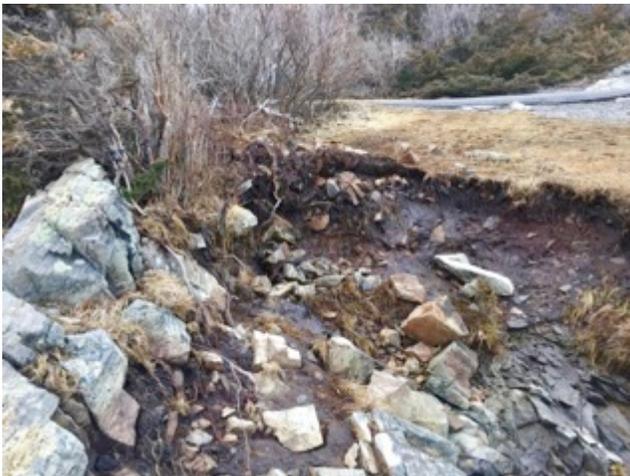
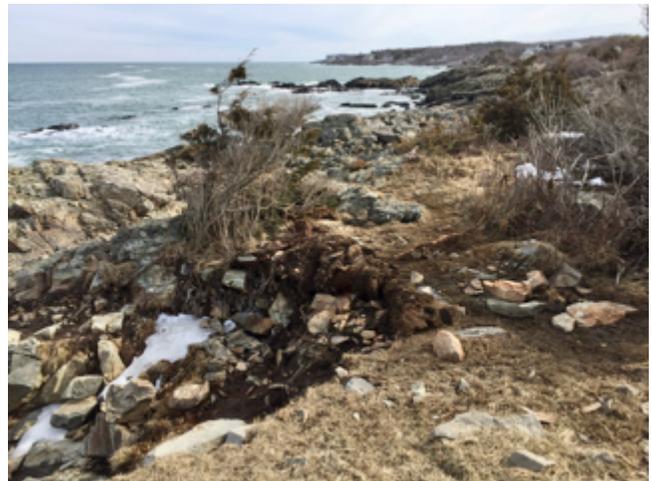
Detail of erosion on left side of above photo.

Save these plants!

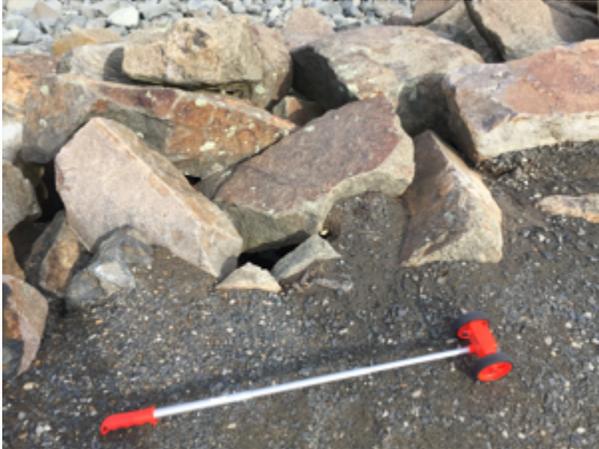
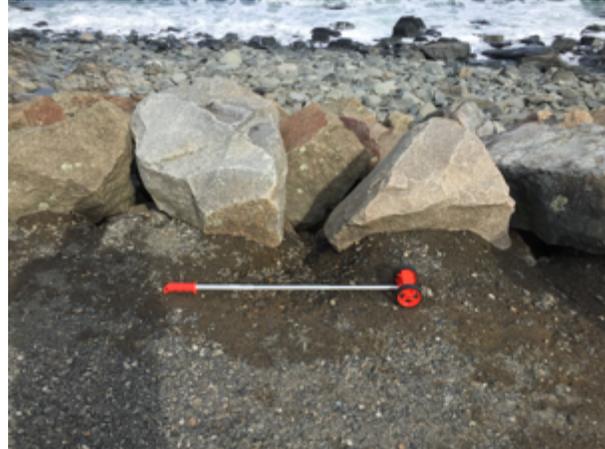
In front of Bench 26, line of old riprap on Oceanside – runoff is causing lose of soil/gravel between riprap stones. One idea offered: slow water runoff and prevent further soil erosion by placing pieces of landscape cloth between large boulders and then using graduated sizes of gravel to fill in crevices?

More washouts between large boulders just as path divides at the Plaque island.

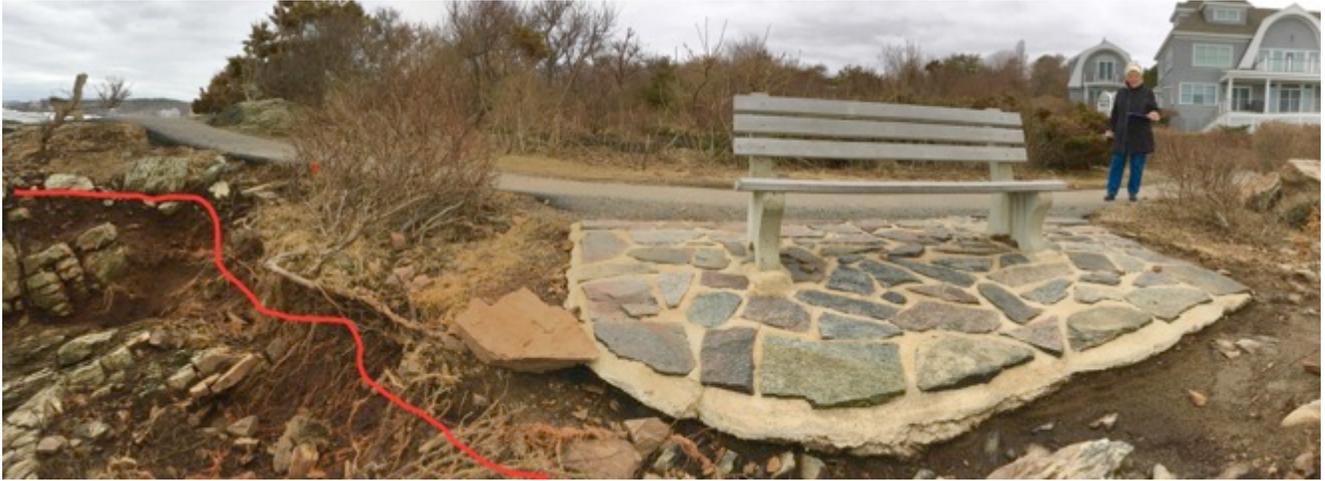
11. Bench 29 – **HIGH PRIORITY** - Soil and rocks washed away at base of bench apron. Severe erosion to the south of the bench, coming very close to edge of paving. One Suggestion: build a wall out beyond apron, following the contours of the land, and get pinned to existing native rock. **13-15' long, varying from 2 to 4' high.**

Rope off and post south of the bench to prevent further loss of embankment.

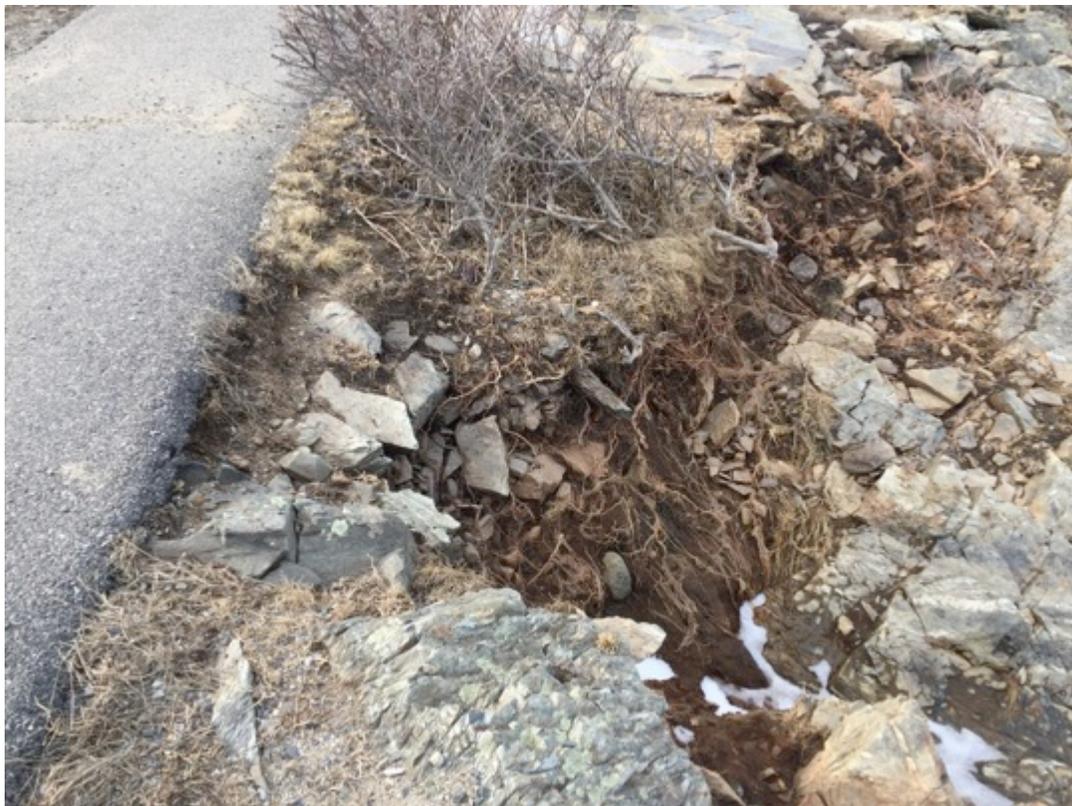
Looking down from path at steep drop off south of B 29. Loose stones and soil will break down easily if people use this spot to climb down to the rocks and tidal pools below. Must preserve and reinforce this existing edge of path.

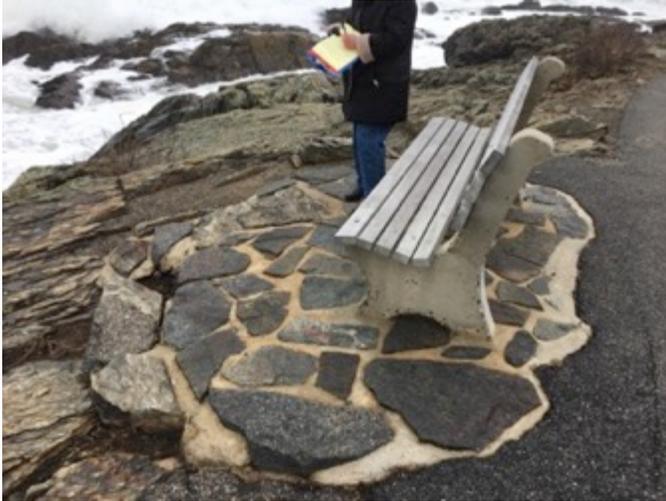
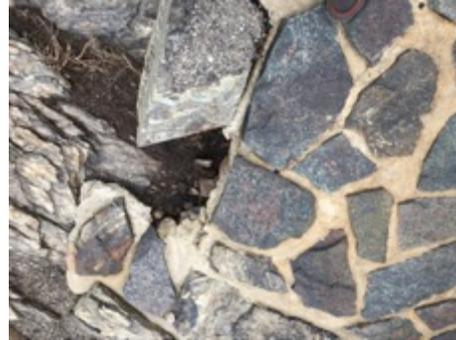
12. Bench 30 – small but careful repair of missing stones in apron.

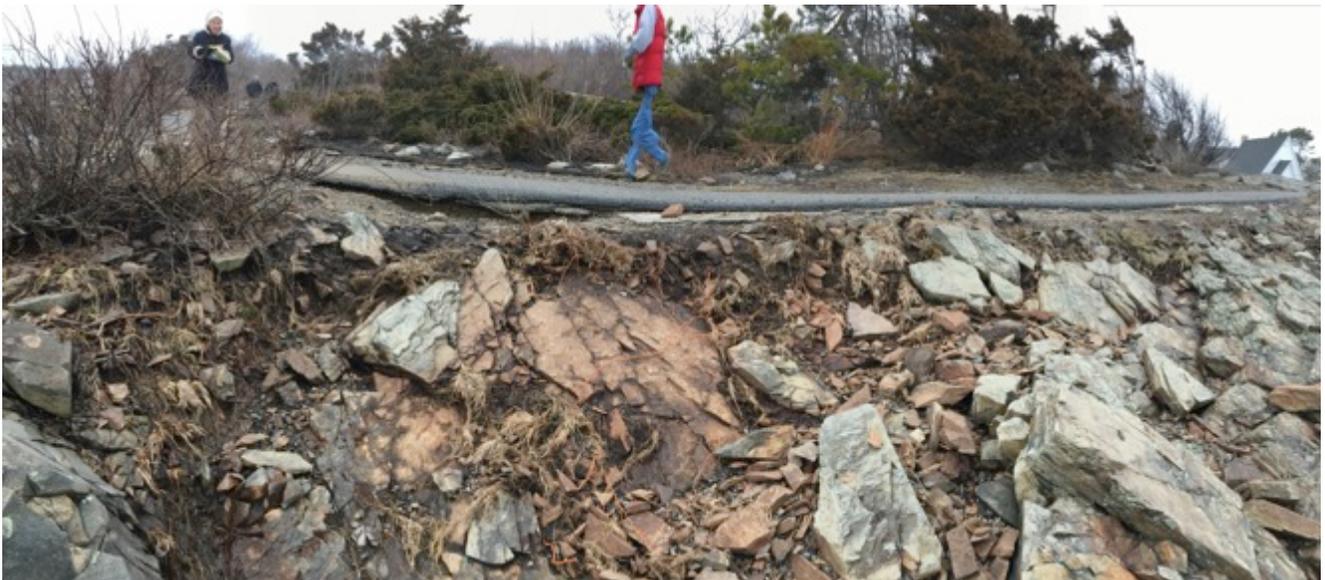
13. Between Benches 30 & 31 – washout on the north (left side) of the clump of bushes. How to stabilize this drop off? How to support the path shoulder that has washed out?

***N of bench, 8' of curbing as immediate support of edge of macadam needed.

Rope off and post edge of path.

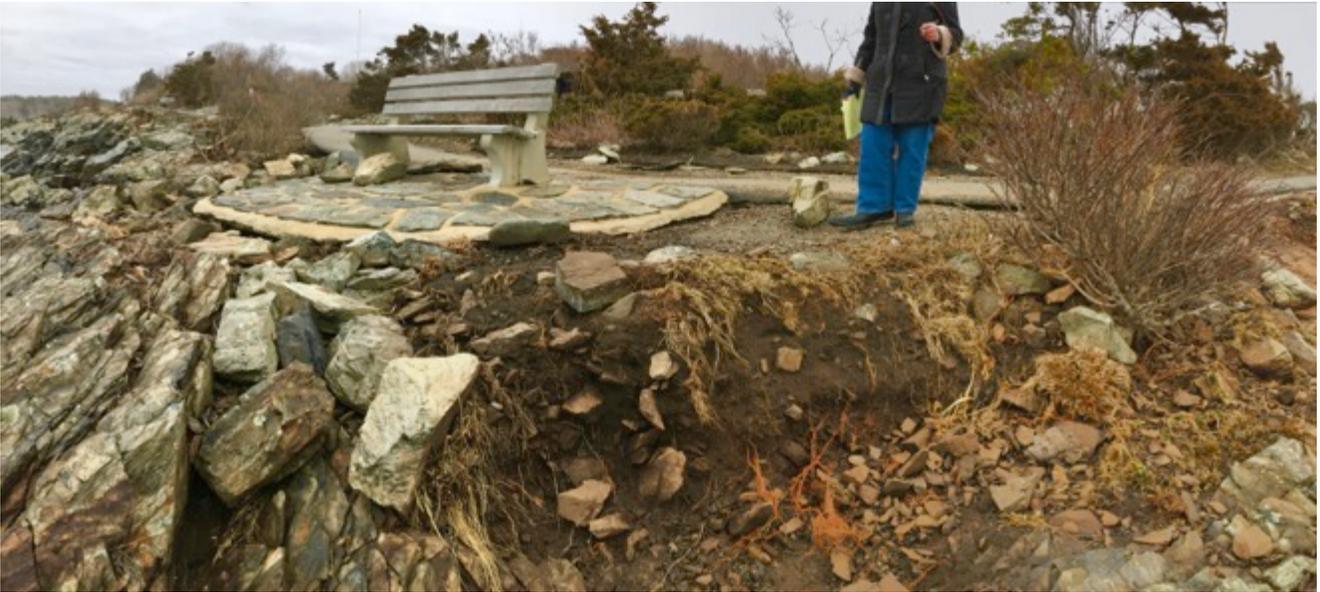
14. Bench 31 – **PRIORITY** to the north of the bench, a steep drop off of earth. How to protect bench platform and earth embankment on N side?

N side of bench platform –embankment breaking down (buffer for the bench)
S side of bench platform – washout - loose rocks that have broken apart from larger formations jeopardize embankment and platform on this side.

Rope off and post fragile edge North of bench

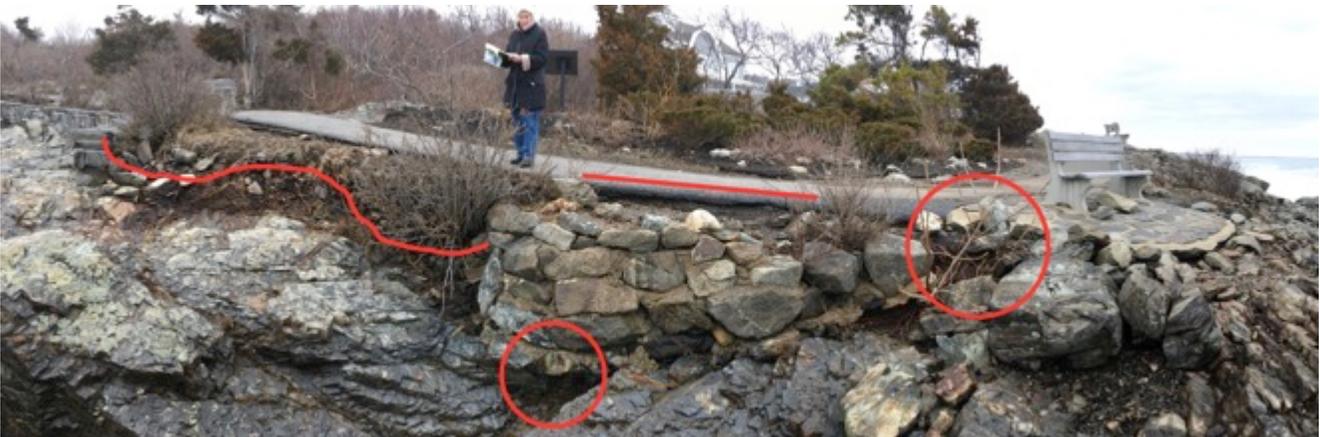
15. In front of Plaque site – S of Bench 31 (right side photo)- severe erosion from B31 to north end of “Rose” wall (rose bushes planted behind wall) – far left in photo. The rose wall was built about 5 or 6 years ago.

18-20' from N end of Rose wall (far left) to old stone work –reinforce at S end of B 31 (right side photo)

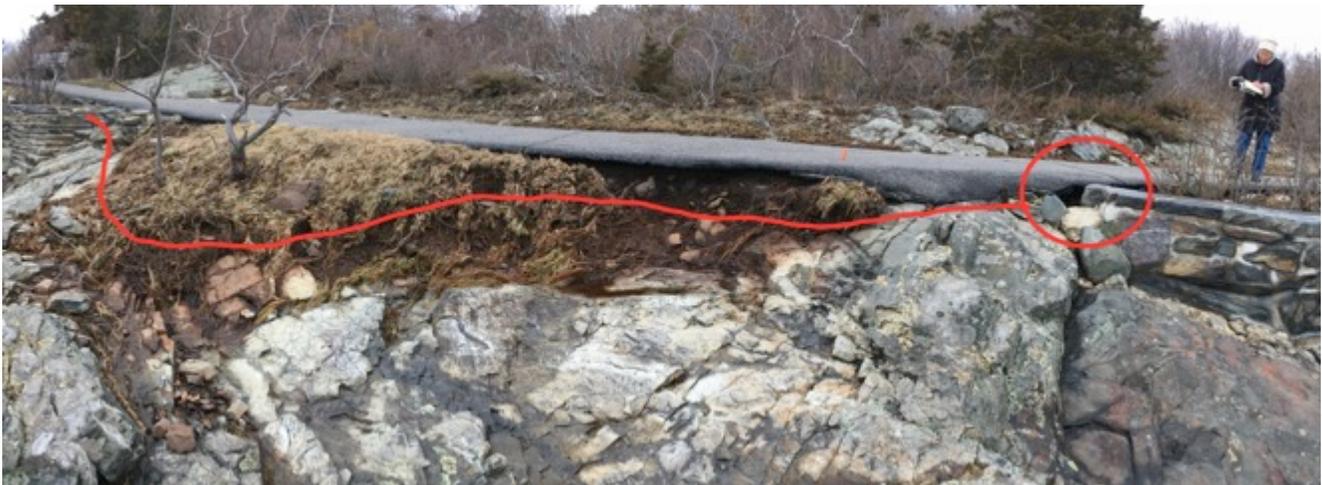
17. **HIGH PRIORITY** – Suggested: construct a new wall connecting the south end of the Rose wall to the “Curvy” wall (far left in photo), just north of Bench 33. - Extending the new wall around earth bluff with Sumac and backfilling will stabilize and reinforce the pavement where it has been under cut. Extend to #18 at Bench 33 (below). Total length approx.. 100'. Edge of asphalt needs to be filled in underneath and reinforced for support.

Rope off from inside Rose wall past Curvy wall to protect remaining earth.

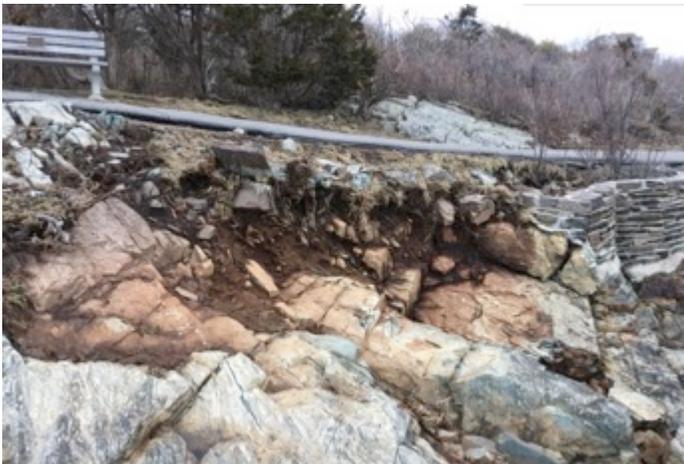
18. Serious erosion between S end of Curvy wall (right side photo) to Bench 33.

Rope and post from Rose wall area continuing past this section to protect earth embankment until repair solutions

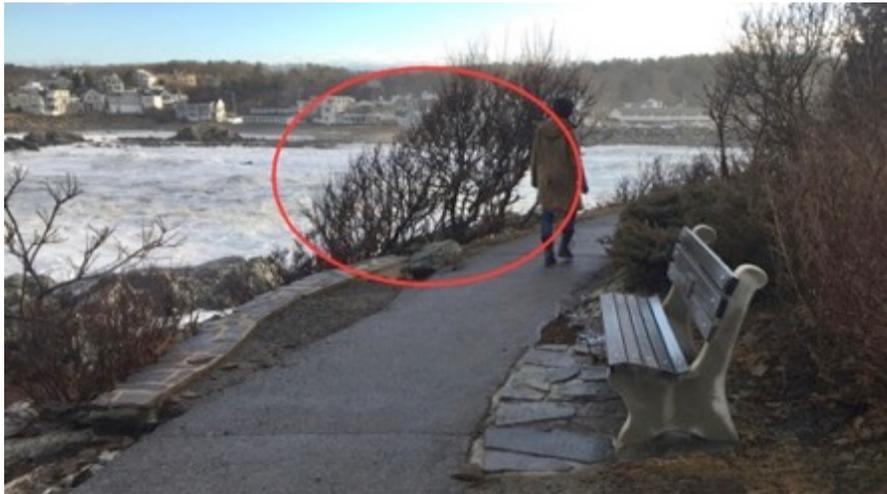
20. Site with three crabapple trees – most of the soil has been washed out at the base of the trees, leaving roots exposed. Challenge – how to add more soil to save trees and keep soil in place? Long term, possibility of installing a low barrier going in front of trees, stopping at old bayberry to the south, then fill in more soil around trees.

Suggested: Short term – a coir log with large stones behind it to hold log in place?

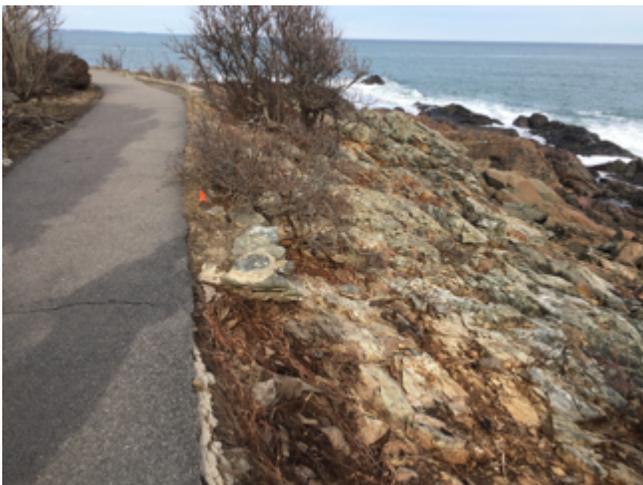
21. SERIOUS erosion– sharp drop off along Oceanside of paving 65' N of Bridge. Extends 44' from cemented stones – red flag – south across rubble of broken stones to next short wall (N of Bridge).

Rope off and post dangerous edge from 65' N of Footbridge to the Bridge

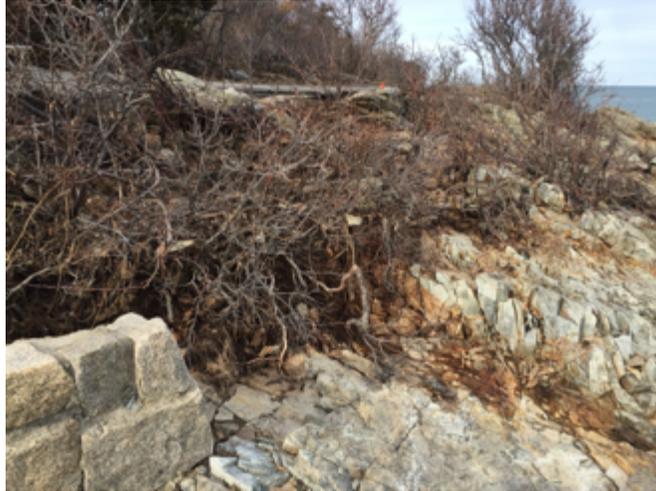
22. SERIOUS - deep washout behind the existing short wall, 35' north of the Bridge.

Suggestion offered: extend wall S past Cedar/Honeysuckle.

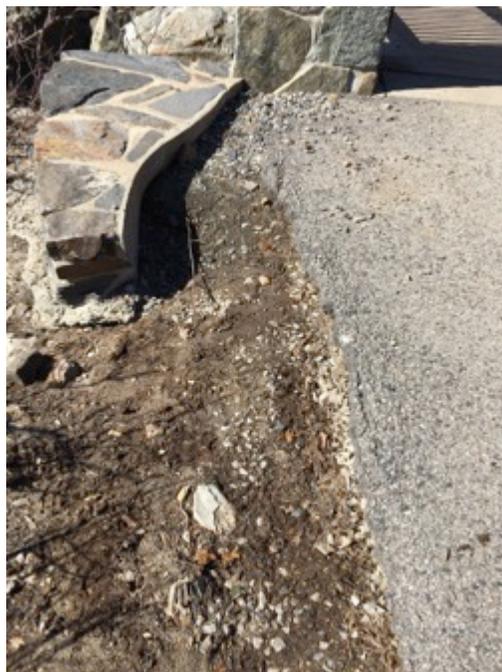
NEW: N Oceanside of Bridge abutment was washed out – tie back into path to protect from further erosion – 5'. The asphalt shoulder dropoff needs remediation.

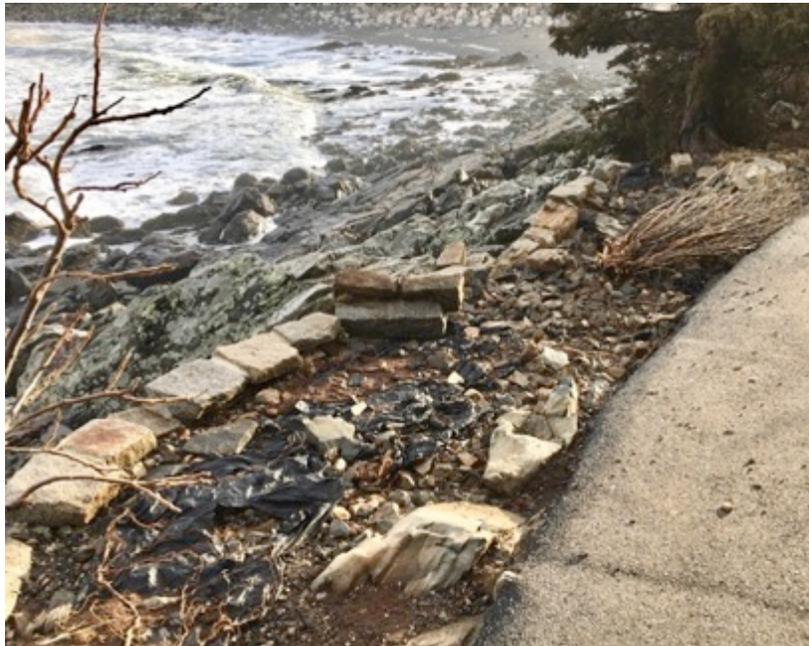
24. South of the Cedar Grove, in front of the Fletcher home (north of Bench 37) – there are two old walls. Southern one is broken up from the storm. One idea proposed: put in new wall, continuing across the front of both old walls, and ending just under the huge Cedar oceanside. **Any work done must not affect or harm this Cedar tree.**

80' – 100'

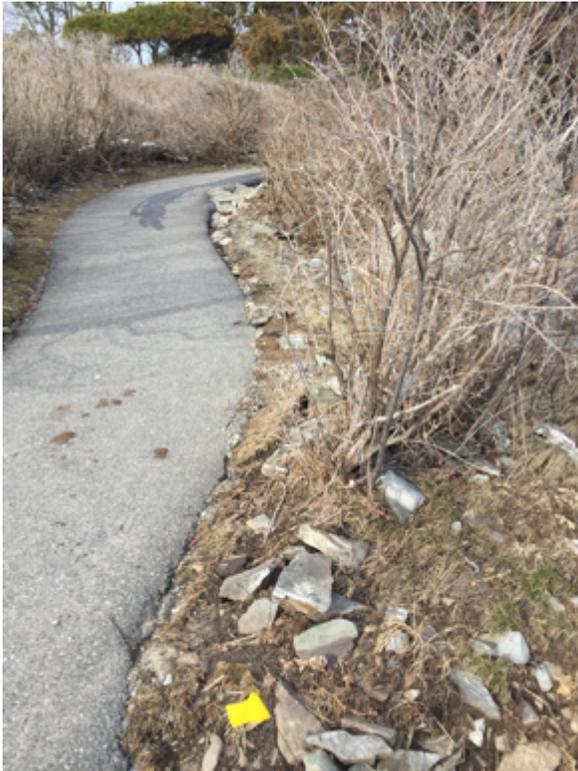
25. South of Bench 37 (just past the huge Cedar, before little cherry tree inland) – fill in washout on Oceanside along asphalt edge.

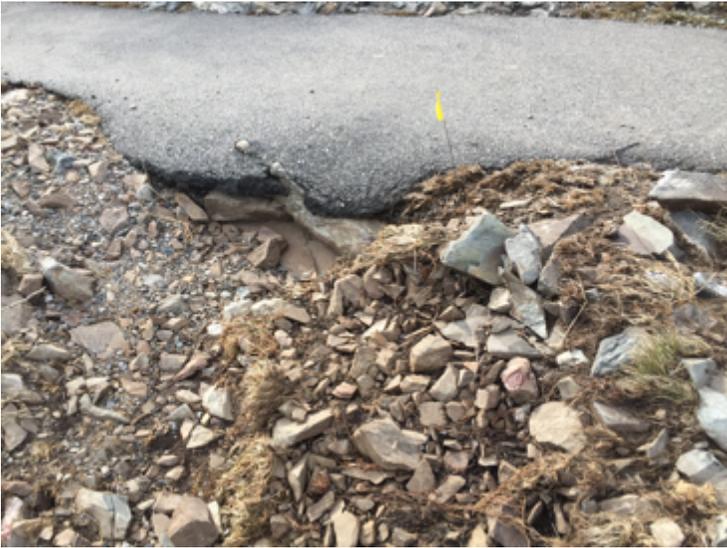
26. Further south from Bench 37 (opposite the little cherry tree), on the curve, there is a 1' drop off on Oceanside of asphalt. Many people walk out to the edge of rocks at this point to take photographs. How to remediate – build up washed out area?

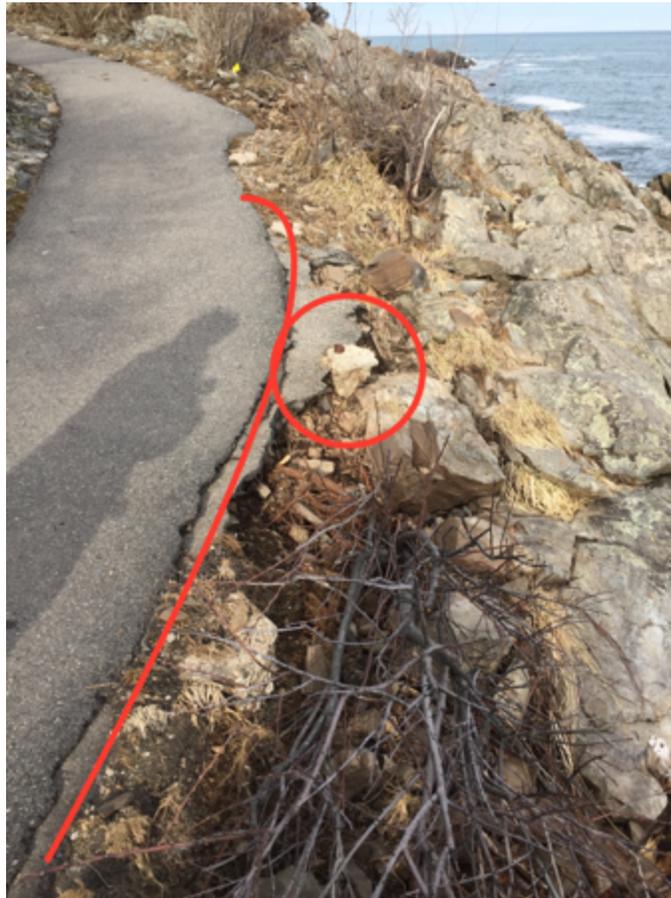
27. **NEW - HIGH PRIORITY** - Further south on curve, there is another sharp drop-off along the edge of path. Look for a cut off **old metal fence pipe** embedded in cement. To the N & S of pipe – problem. **16' length**

Rope off and post North and South of cut-off pipe to protect existing paving

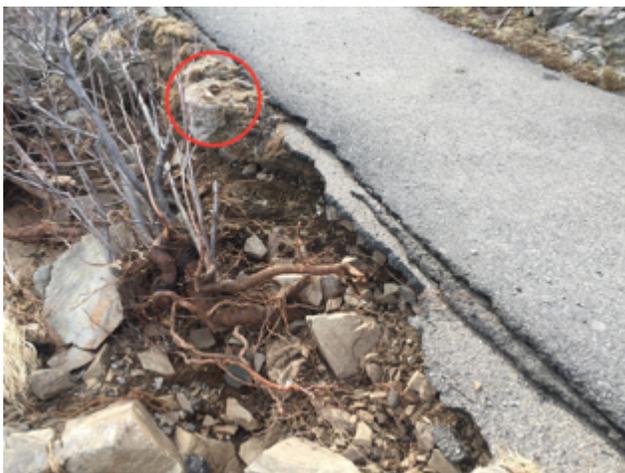
North side of cut pipe

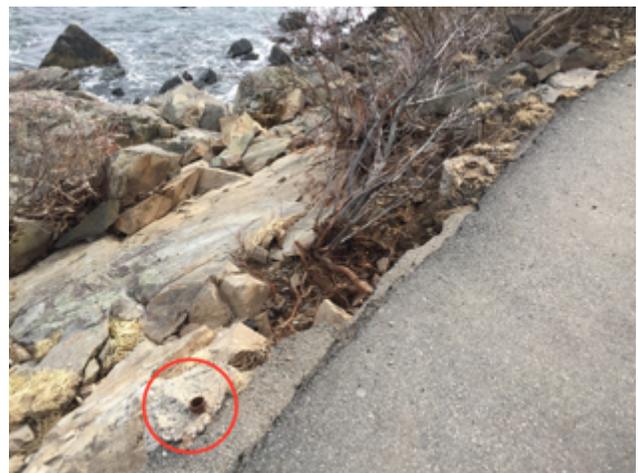
South of cut pipe
